## Charimgar Mosque in Karshi

**Gilmanova Nafisa  
Valiakhmetovna**

### ABSTRACT

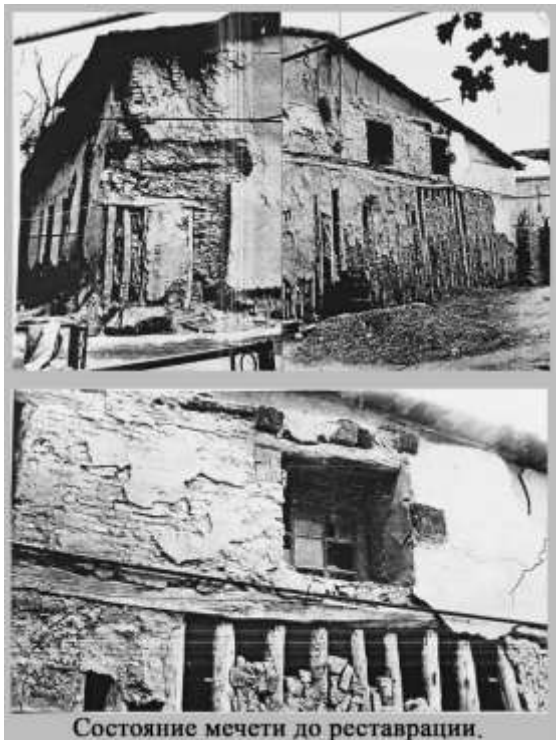
Состояние мечети до реставрации.

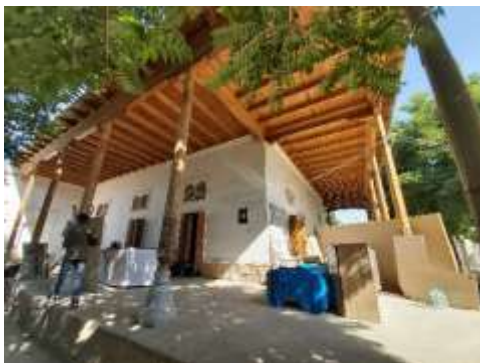
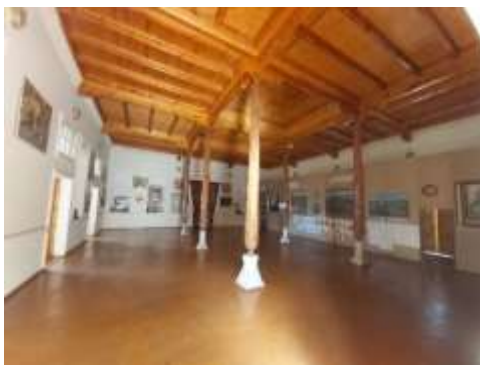
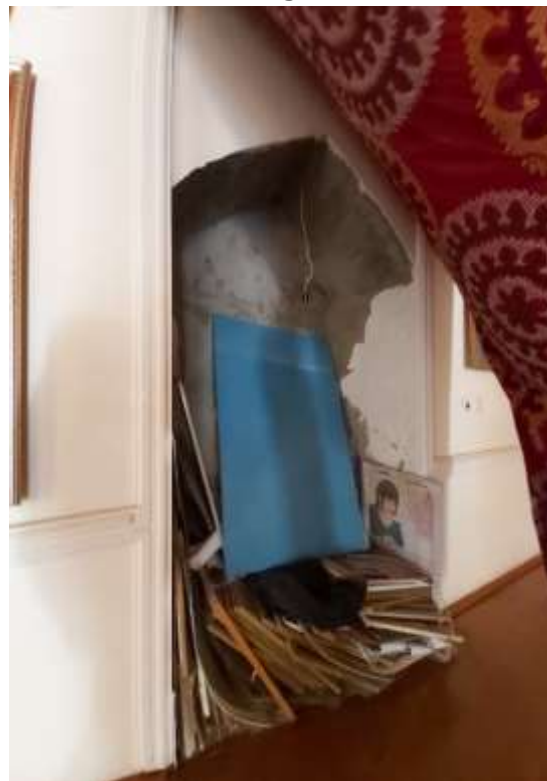
**The current state of the mosque of the XIX century. in Karshi.  
Mihrabnaya nis a.**
