# To The Study of the History of Restoration and Architecture of the Tashkent Madrasah Barakkhan of the 16th Century

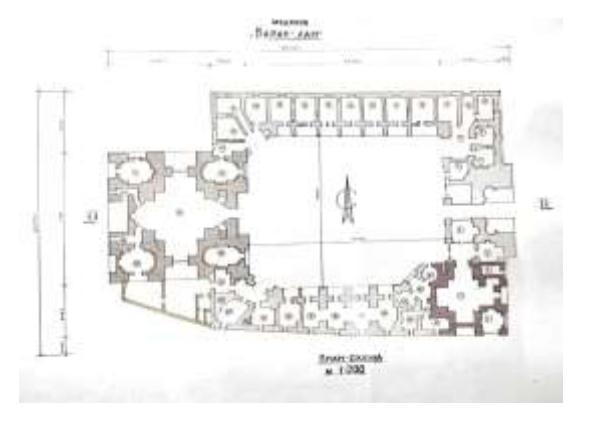
Figure 1: Master plan of Khazrati Imam complex: 1-Barak Khan Madrasah, 2-Suyunch Khan mausoleum, 3-Tilya sheikh mosque, 4-Muyi Muborak Madrasah, 5-chillakhona, 6-entrance to the cemetery, 7-tree (chinar), 8-khauz, 9-Mausoleum of Kaffal Shashi, 10-Mausoleum of Baba Khoja, 11-Namozgokh mosque. (Arkhiv Fine Arts Institute ASR Uz., UA(M)M24Nº770/7, 1974)

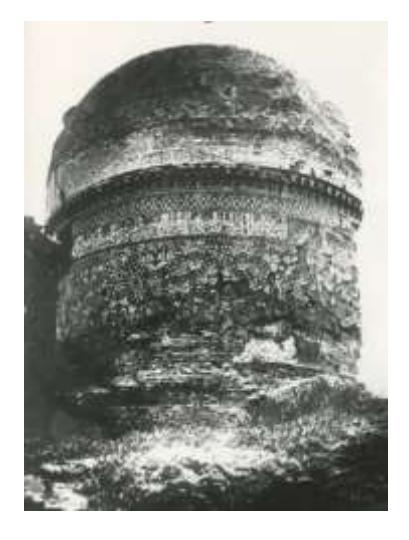
Figure 3: The condition of the dome of Suyunch Khan mausoleum before the earthquake. Photo by D. Ermakov, archive Glav NPU.

*At the first stage* – in 1866, a photo taken by D. Ermakov shows that the dome of the Suyunch Khan mausoleum is in a state before the earthquake (*Fig.3*). This photo shows that: the dome and part of the dome of Suyunch Khan mausoleum are well preserved; the dome ornament and part of the dome are partially lost; part

of the dome is covered with blue plates; the complex mosaic geometric "girikh" pattern and

epigraphic inscriptions on the upper part are poorly preserved.

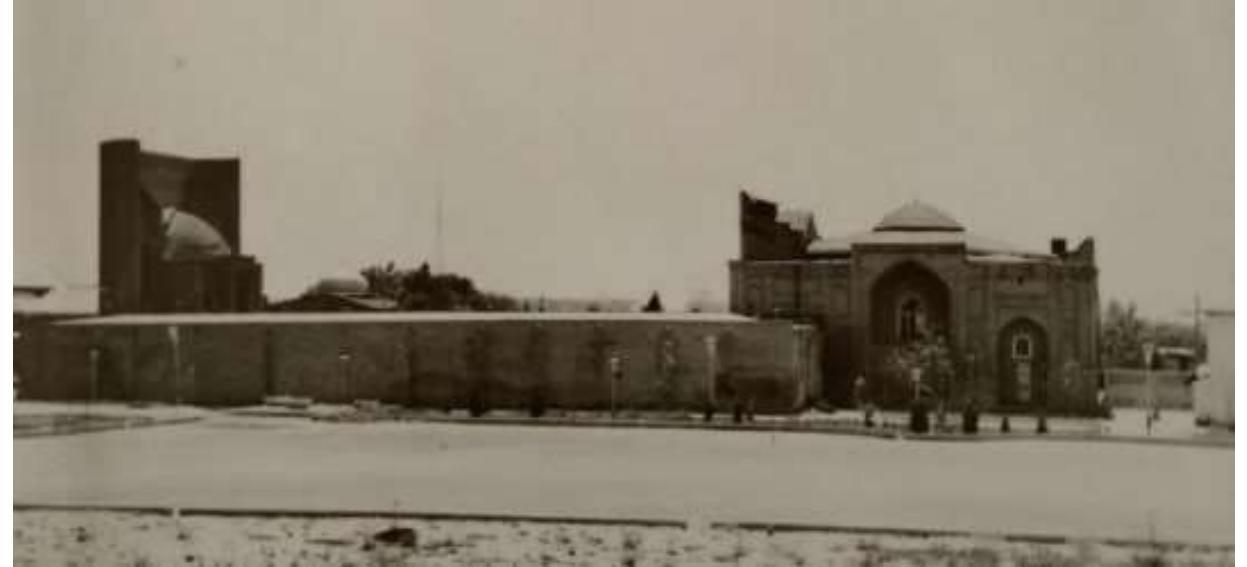
Figure 4: General view of the Barak Khan Madrasah from the north side. Archiv Glav NPU, 1983.

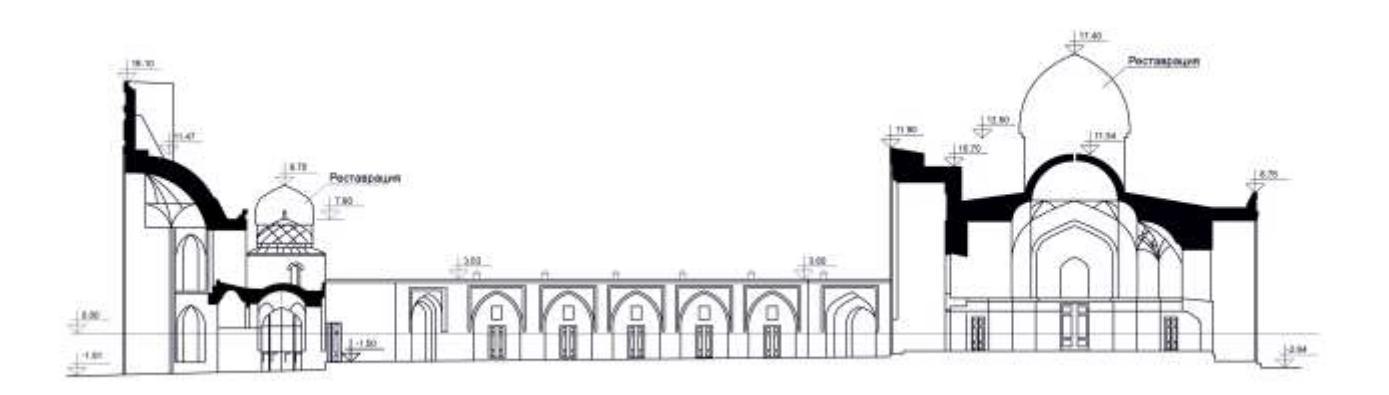
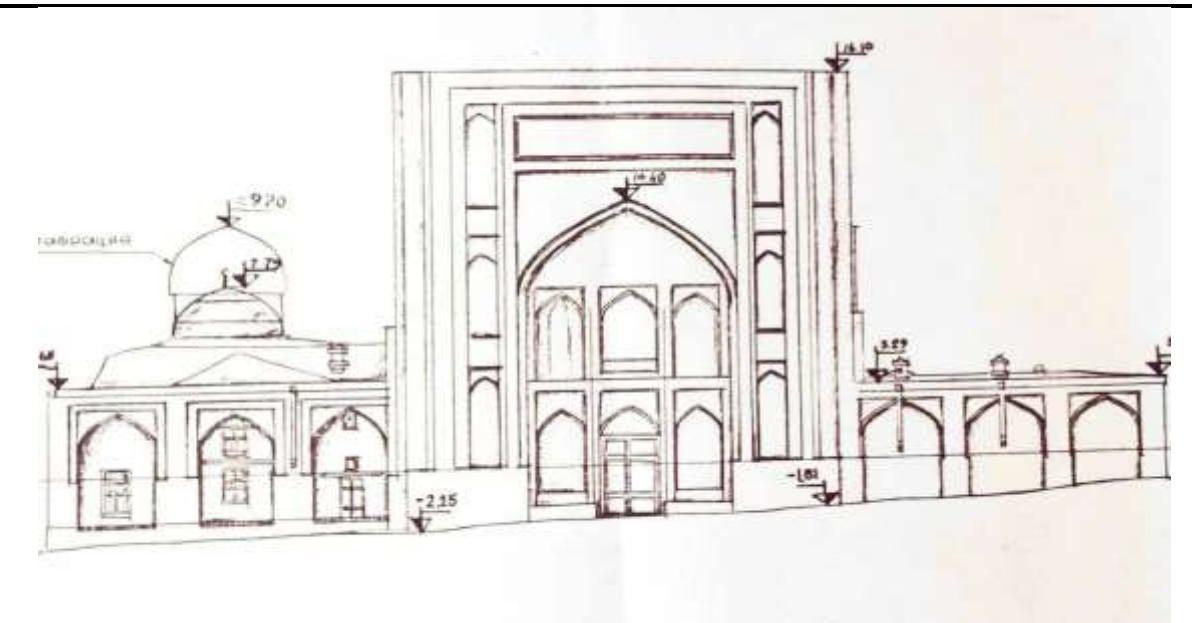
Figure 5: Reconstruction project of the Barak Khan madrasah, completed in 1956: a) drawing of the main facade, b) section of the madrasah, Glav NPU Archive T4754/И20

Also with the aim of reconstructing the building in 1949-1956 architects-restorers A.N. Vinogradov [10], S. Bespaly, V.T. Rasskazovsky, V. Taikalov, G.N. Nikitin developed science-based projects [11], [12]. As a result, in 1955-1956 on the basis of historical data collected by these developed (Fig. 5).

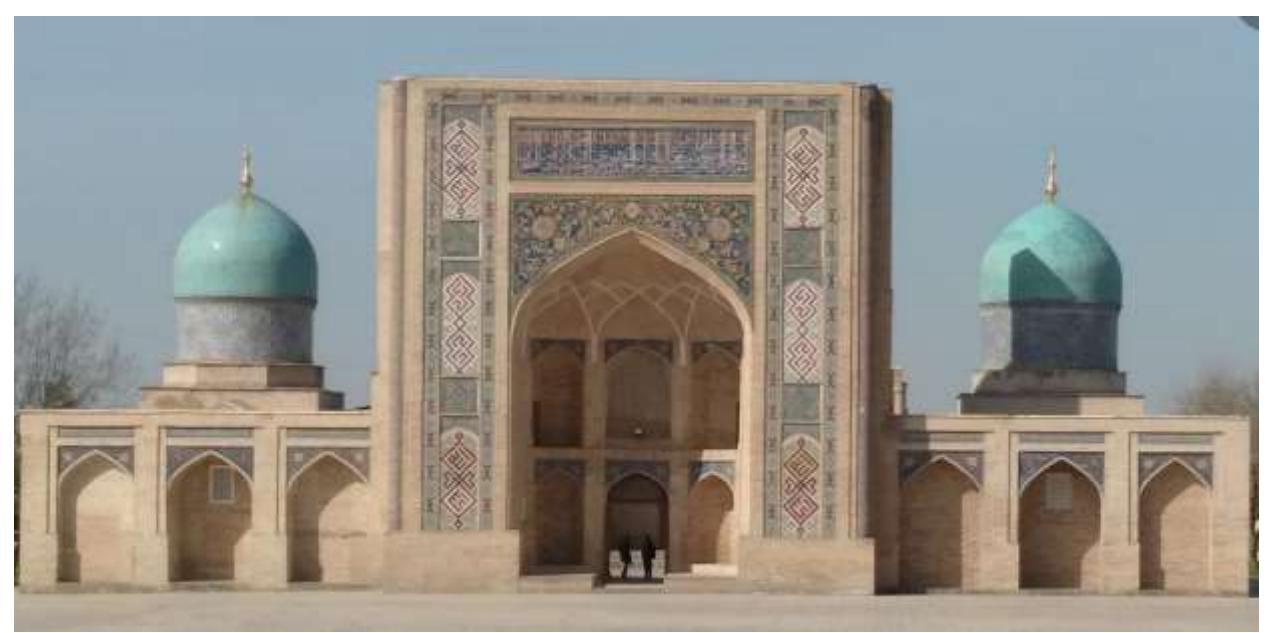
Figure 5: The main facade of the Barak Khan madrasah. Photo by M. Beknazarova, 2022.

The photograph obtained by the editor also reflects how the main facade of the building and the overall appearance of the madrasah have been completely restored, surahs from the Holy Quran restored in one part of the dome of mausoleum Suyunch Khan, the side vaults of the entrance portal decorated with patterned panels, these panels show geometric writings, Islamic, geometric inscriptions - girikhi, In the upper part of the entrance dome is a rectangular panel with verses from the Quran. During roof renewal a "kolipqori" method from fired bricks was used, also the outer dome of a small mausoleum located on the left side of the main facade was restored, and to give symmetry balance another dome of the same kind was installed on the right side of the main facade (Fig.5-6-7).

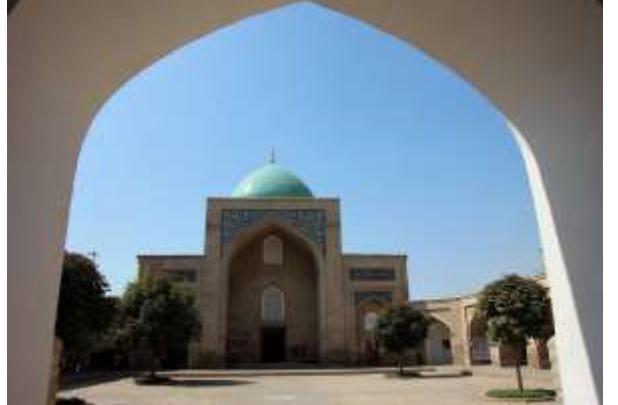
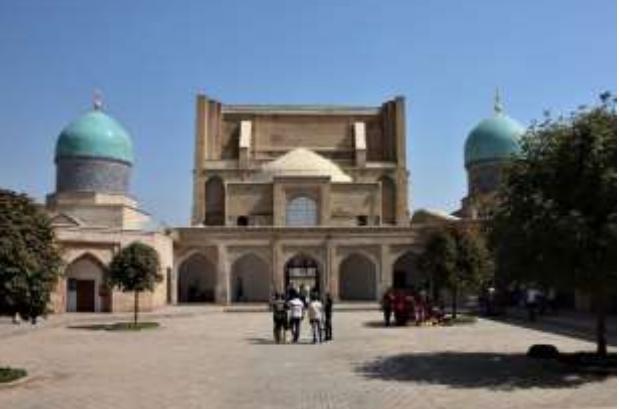
Figure 6: The portal of the Suyunch Khon Figure 7: View from the courtyard of the mausoleum, Photo by M. Beknazarova, 2022. 2022.
